Philpott Project Drought Update—4 March 2003

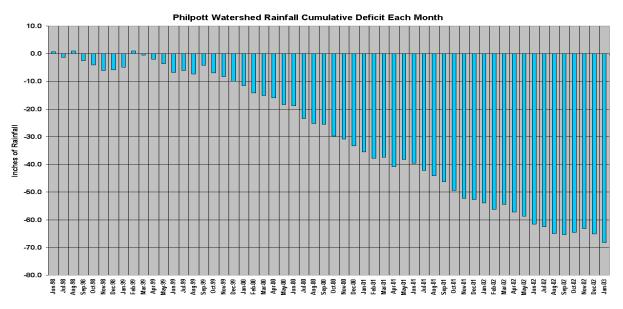
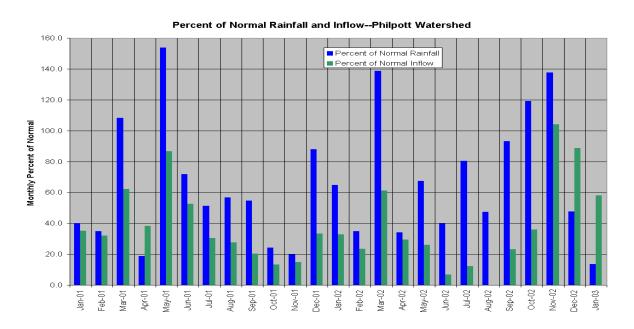
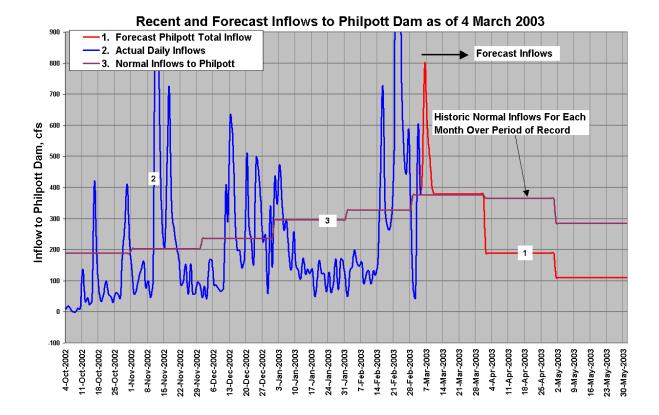
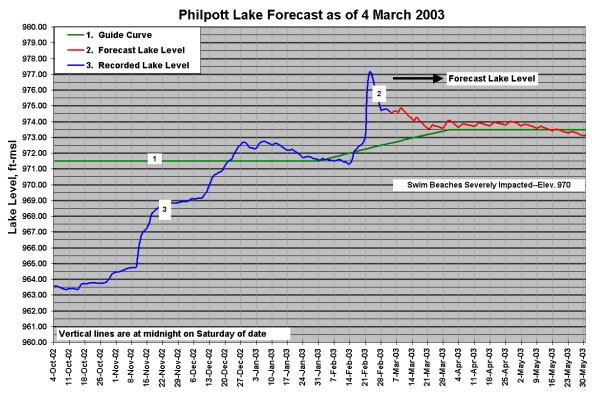
1. Status of Inflows into Philpott Dam and the Philpott Lake level. As of this report, Philpott Lake is at 974.8 feet, msl or about two feet above guide curve. Extra releases will be made from Philpott Dam until the lake level approaches the rising guide curve. Please note that the projected lake level may be changed without notice as inflows and releases change in response to basin needs. Due to being above guide curve, normal release patterns will resume from Philpott Dam but will be closely monitored. If a resumption of drought conditions appear, then reduced releases will be considered.
